PROJECT SOLUTIONS

Project: York Administration Center
Application: Cooling Towers / Outdoor Equipment

Retrofit partial acoustical louver barrier solves neighbourhood noise problem.

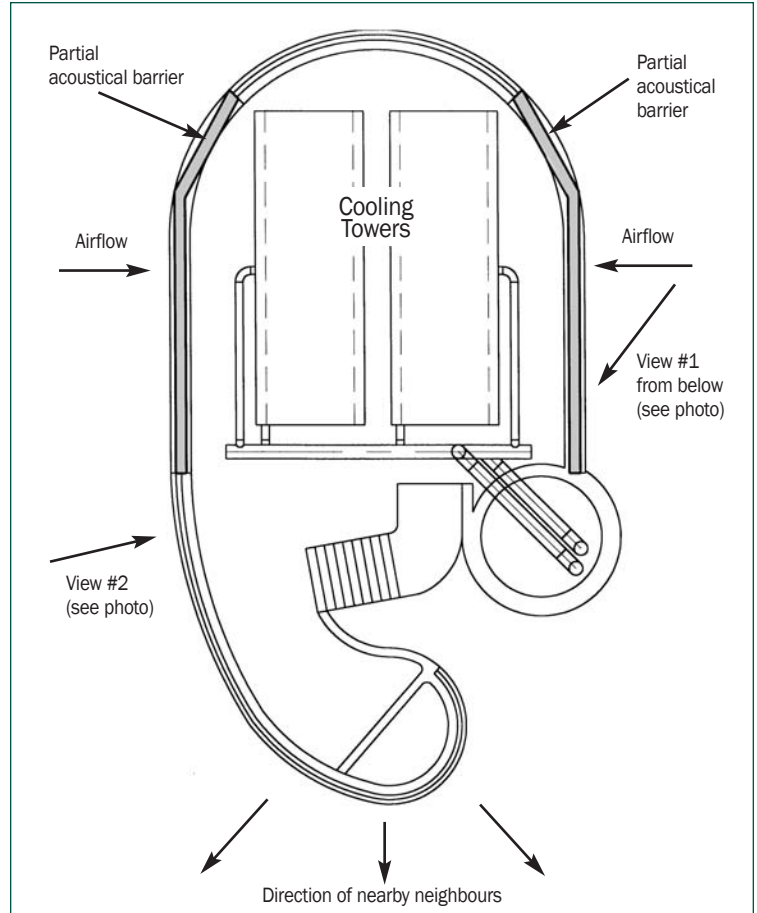
Plan View

Line of sight from the cooling tower intakes to the homes nearby was blocked by partial acoustical louver barriers on each side of the towers.

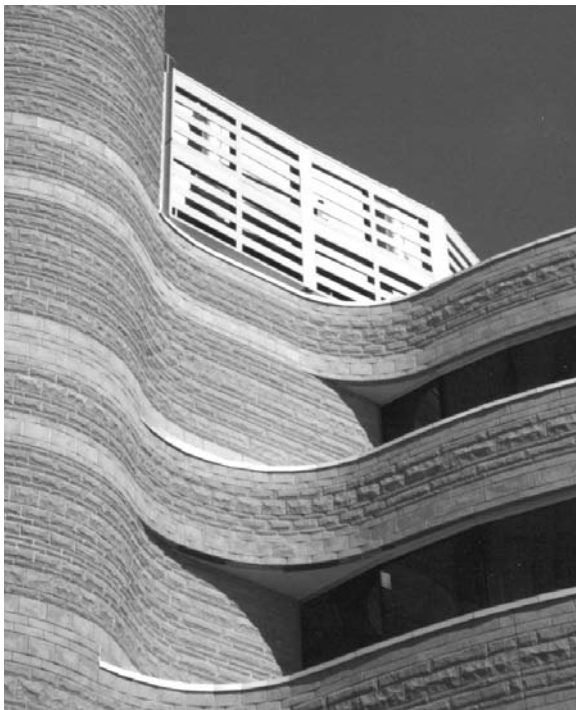
View #1: Looking up through the acoustical louver air passage.

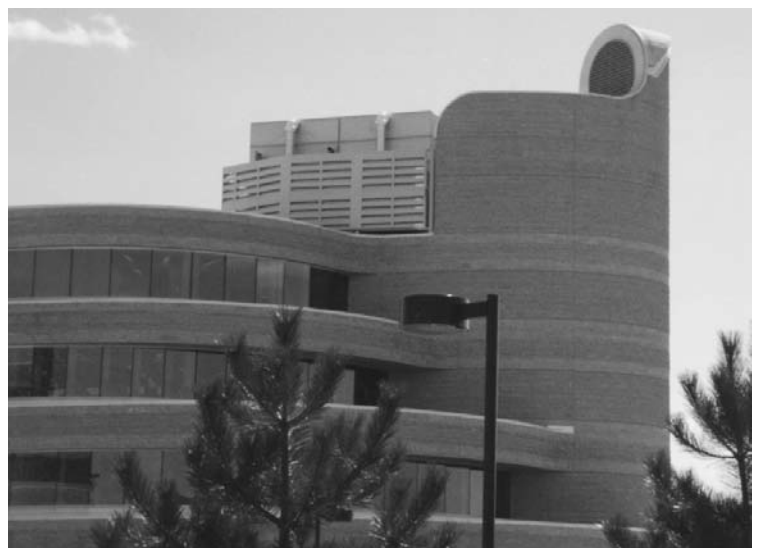
View #2: Acoustical louvers block cooling tower air intake's line of sight.
